CHAOTIC FAÇADE

ACCESSIBILITY

ROOF PROBLEMS

OBSOLETE SERVICES

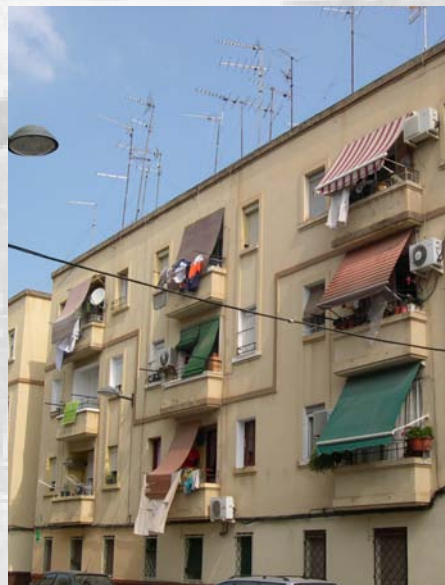
electrical wiring
balconies
AIR CONDITIONING
different window frames
multiplicity of elements
CLOTHES HANGING
sunshading

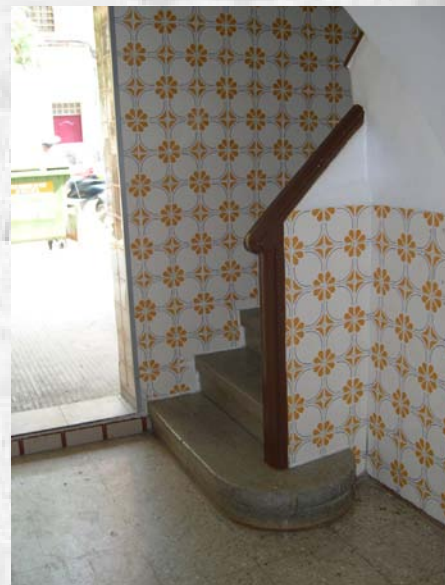
difficult access
NARROW STAIRCASE
mail boxes
NO ELEVATOR
slippery paving
handrail height

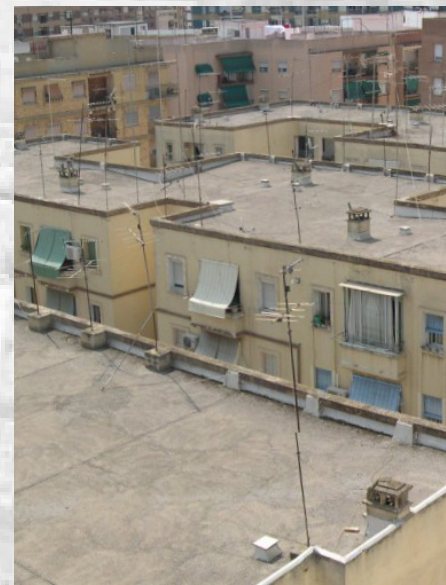
WATERPROOFING
lack of insulation
soil vent pipes
expansion joints
DRAINAGE
multiplicity of antennae

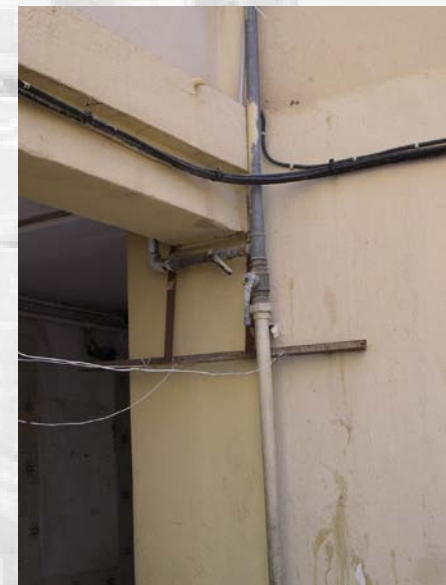
no mechanical rooms
no comply with regulations
WIRING ON VIEW
no gas supply
insufficient electrical supply
LACK OF VENTILATION

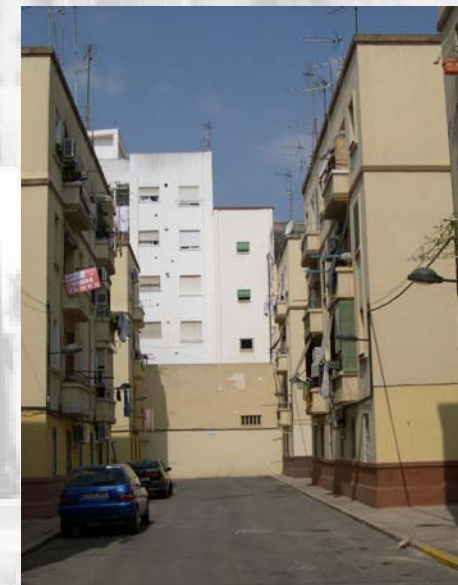
INNER ALLEYS

CUL-DE-SAC
traffic problems
SOCIAL CONFLICTS
lack of urban space
asphalt paving
lack of greenary

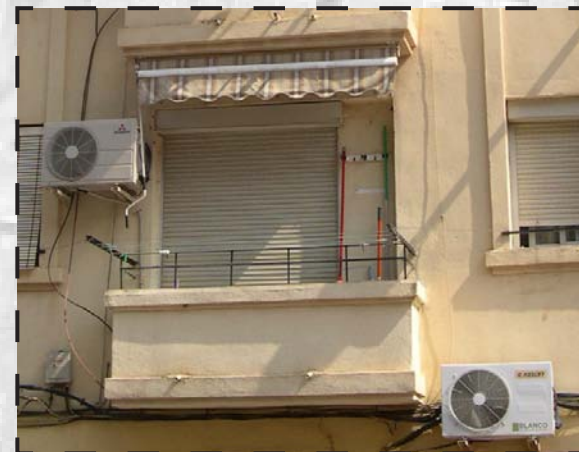
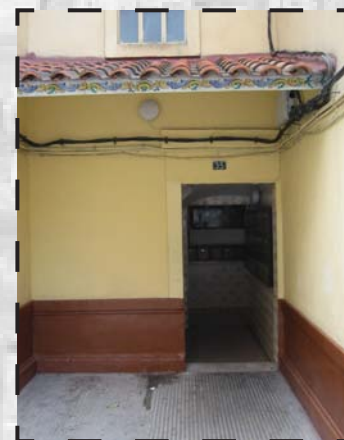
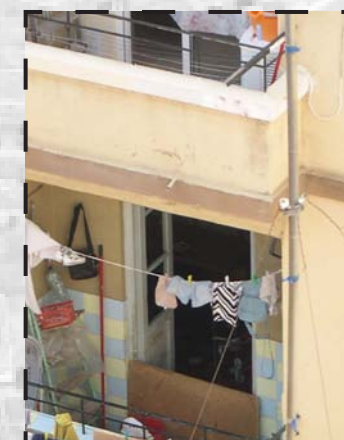
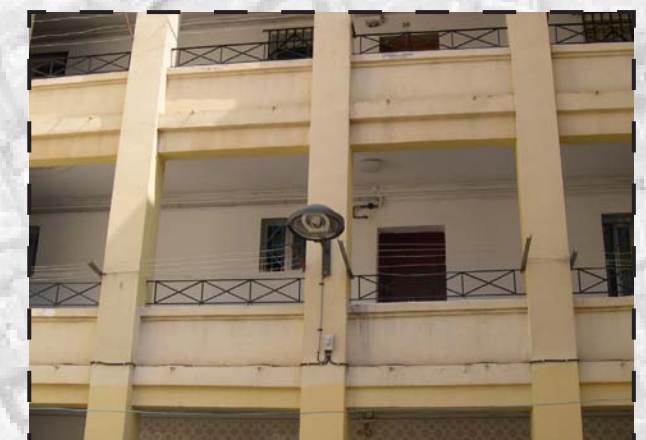
CHAOTIC FAÇADE

Each balcony has its own window frame, sunshading system, colour... There is no appropriate place for hanging clothes. Air conditioning machines are placed anywhere. Façade surface presents cracks and plaster is peeling off.

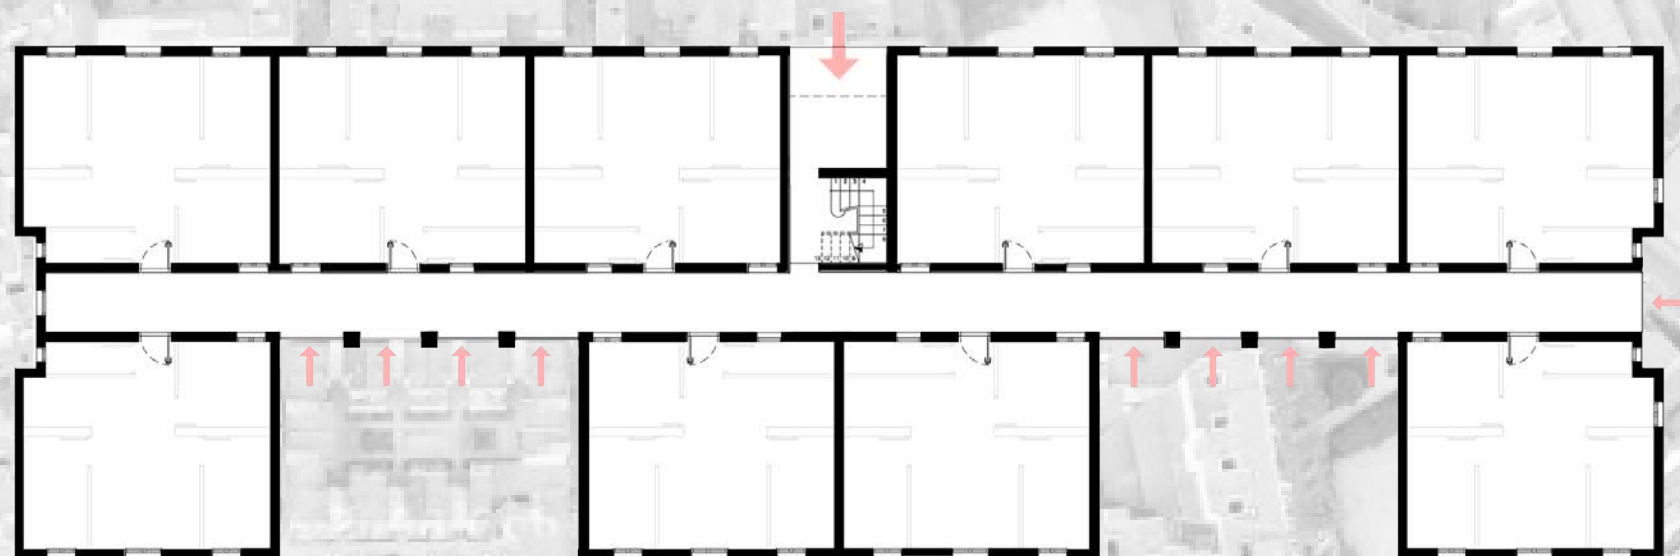
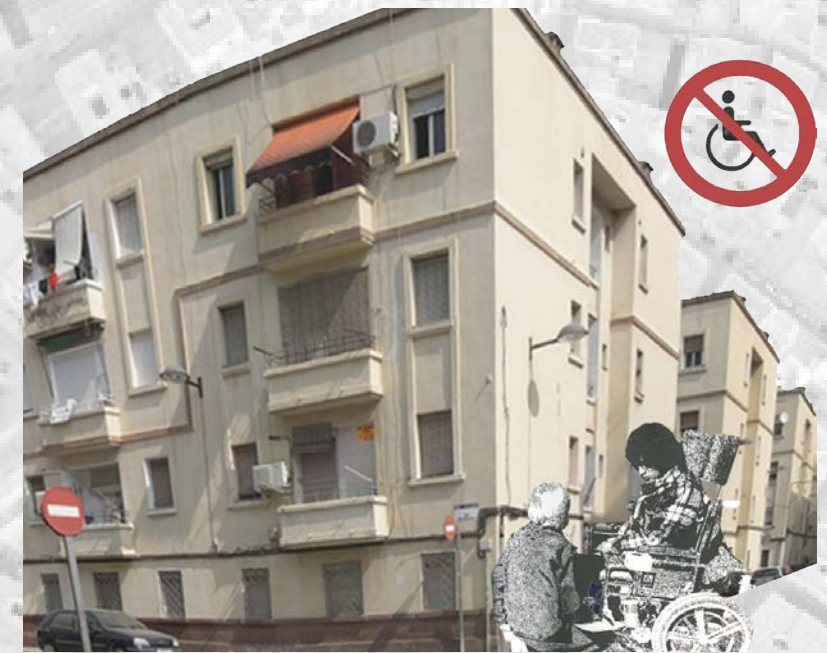
LIMITED ACCESS Each block has a single access with a narrow staircase for every 40 dwellings. There is no elevator, so elderly and handicapped living in the upper floors can hardly reach the street. Access into the block is uncontrolled. Each neighbour in the block has personalized walls and entry door in the access corridor.

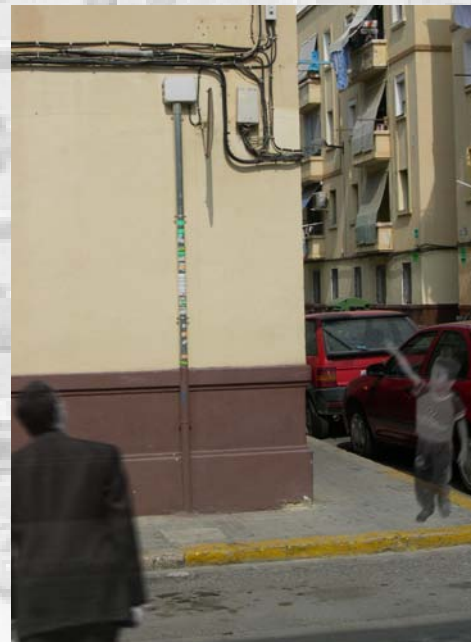
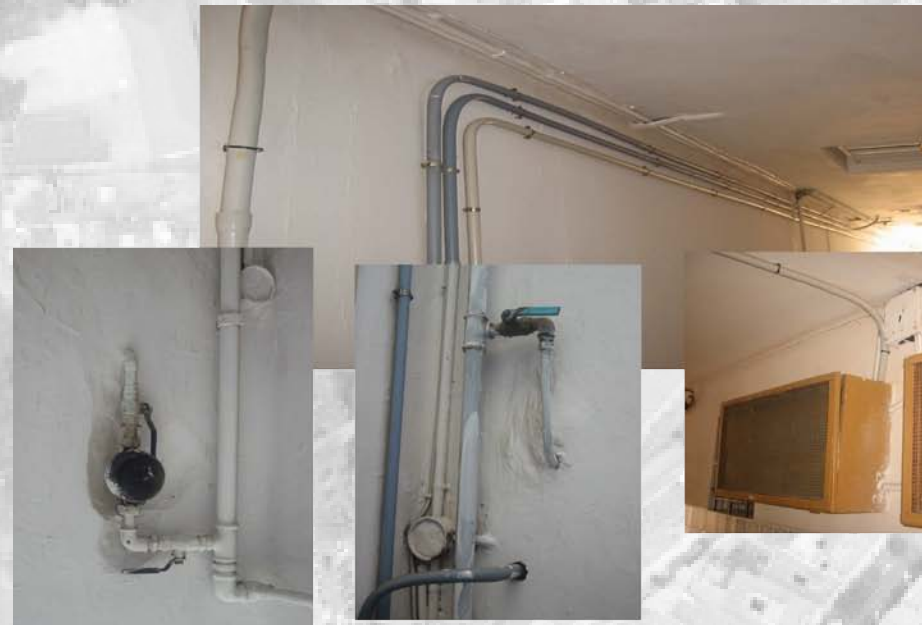
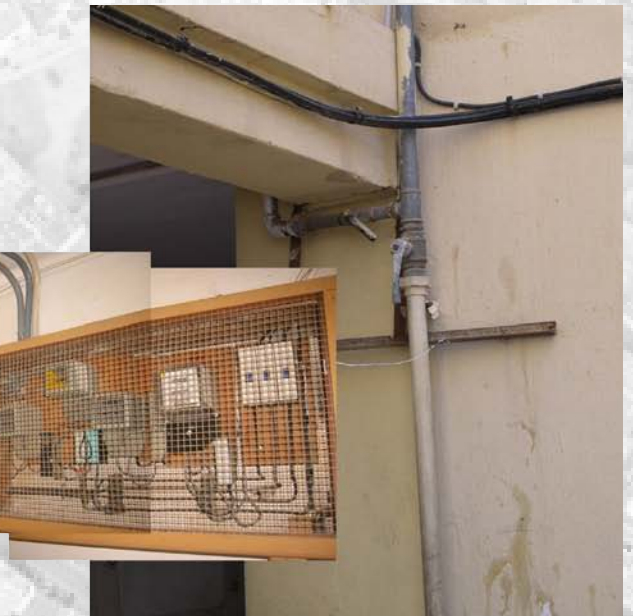
LACK OF INSULATION

There was waterproofing problems due to aging of materials and not enough slope. Ducts ventilation didn't work properly due to its insufficient height. Antennae were old and anywhere. Access to the roof was complicated. There was no specific service rooms. Water and electrical counters are placed in cupboards on the corridors. Wiring materials were obsolete and infradimensioned.

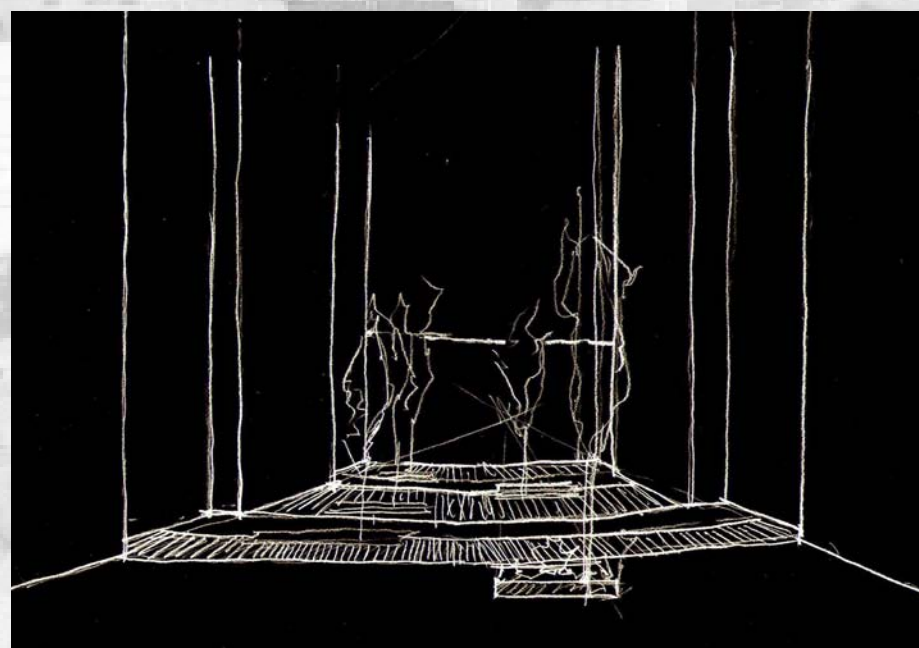
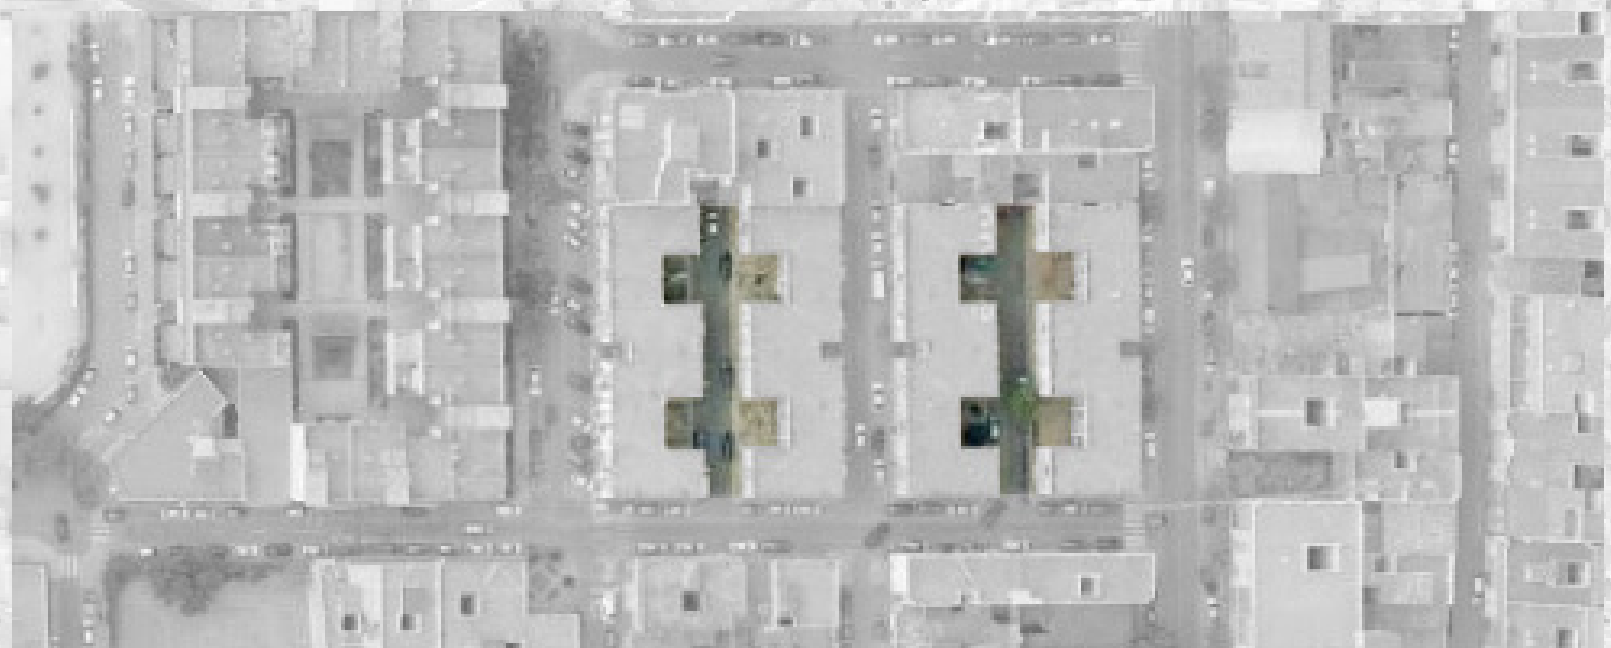
SOCIAL PROBLEMS Due to the fact of being a cul-de-sac typology it enhanced problems of different nature. Drug consumption and dealing, waste accumulation, noise at nights affecting neighbours on the ground floor dwellings. Abandoned parked cars. Direct access from the alley to the blocks.
