CHAOTIC FAÇADE

ACCESSIBILITY

ROOF PROBLEMS

OBSOLETE SERVICES

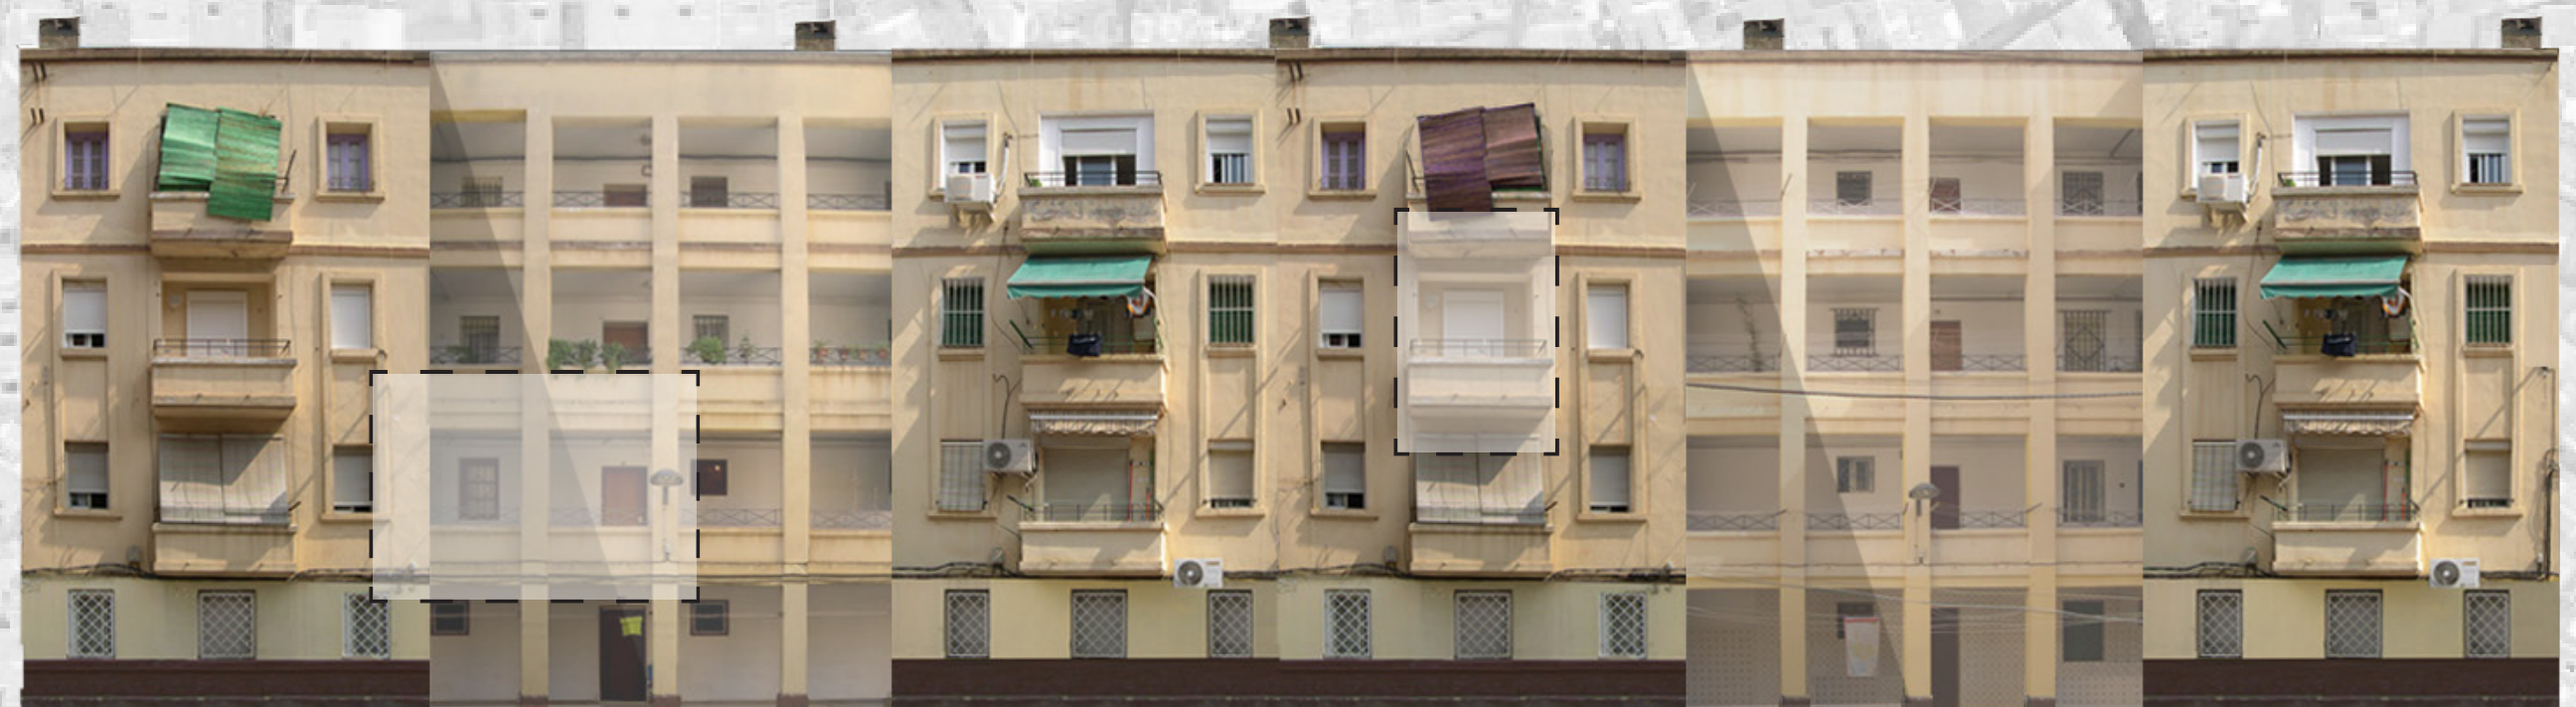
CHAOTIC FAÇADE

Each balcony has its own window frame, sunshading system, colour... There is no appropriate place for hanging clothes. Air conditioning machines are placed anywhere. Façade surface presents cracks and plaster is peeling off.

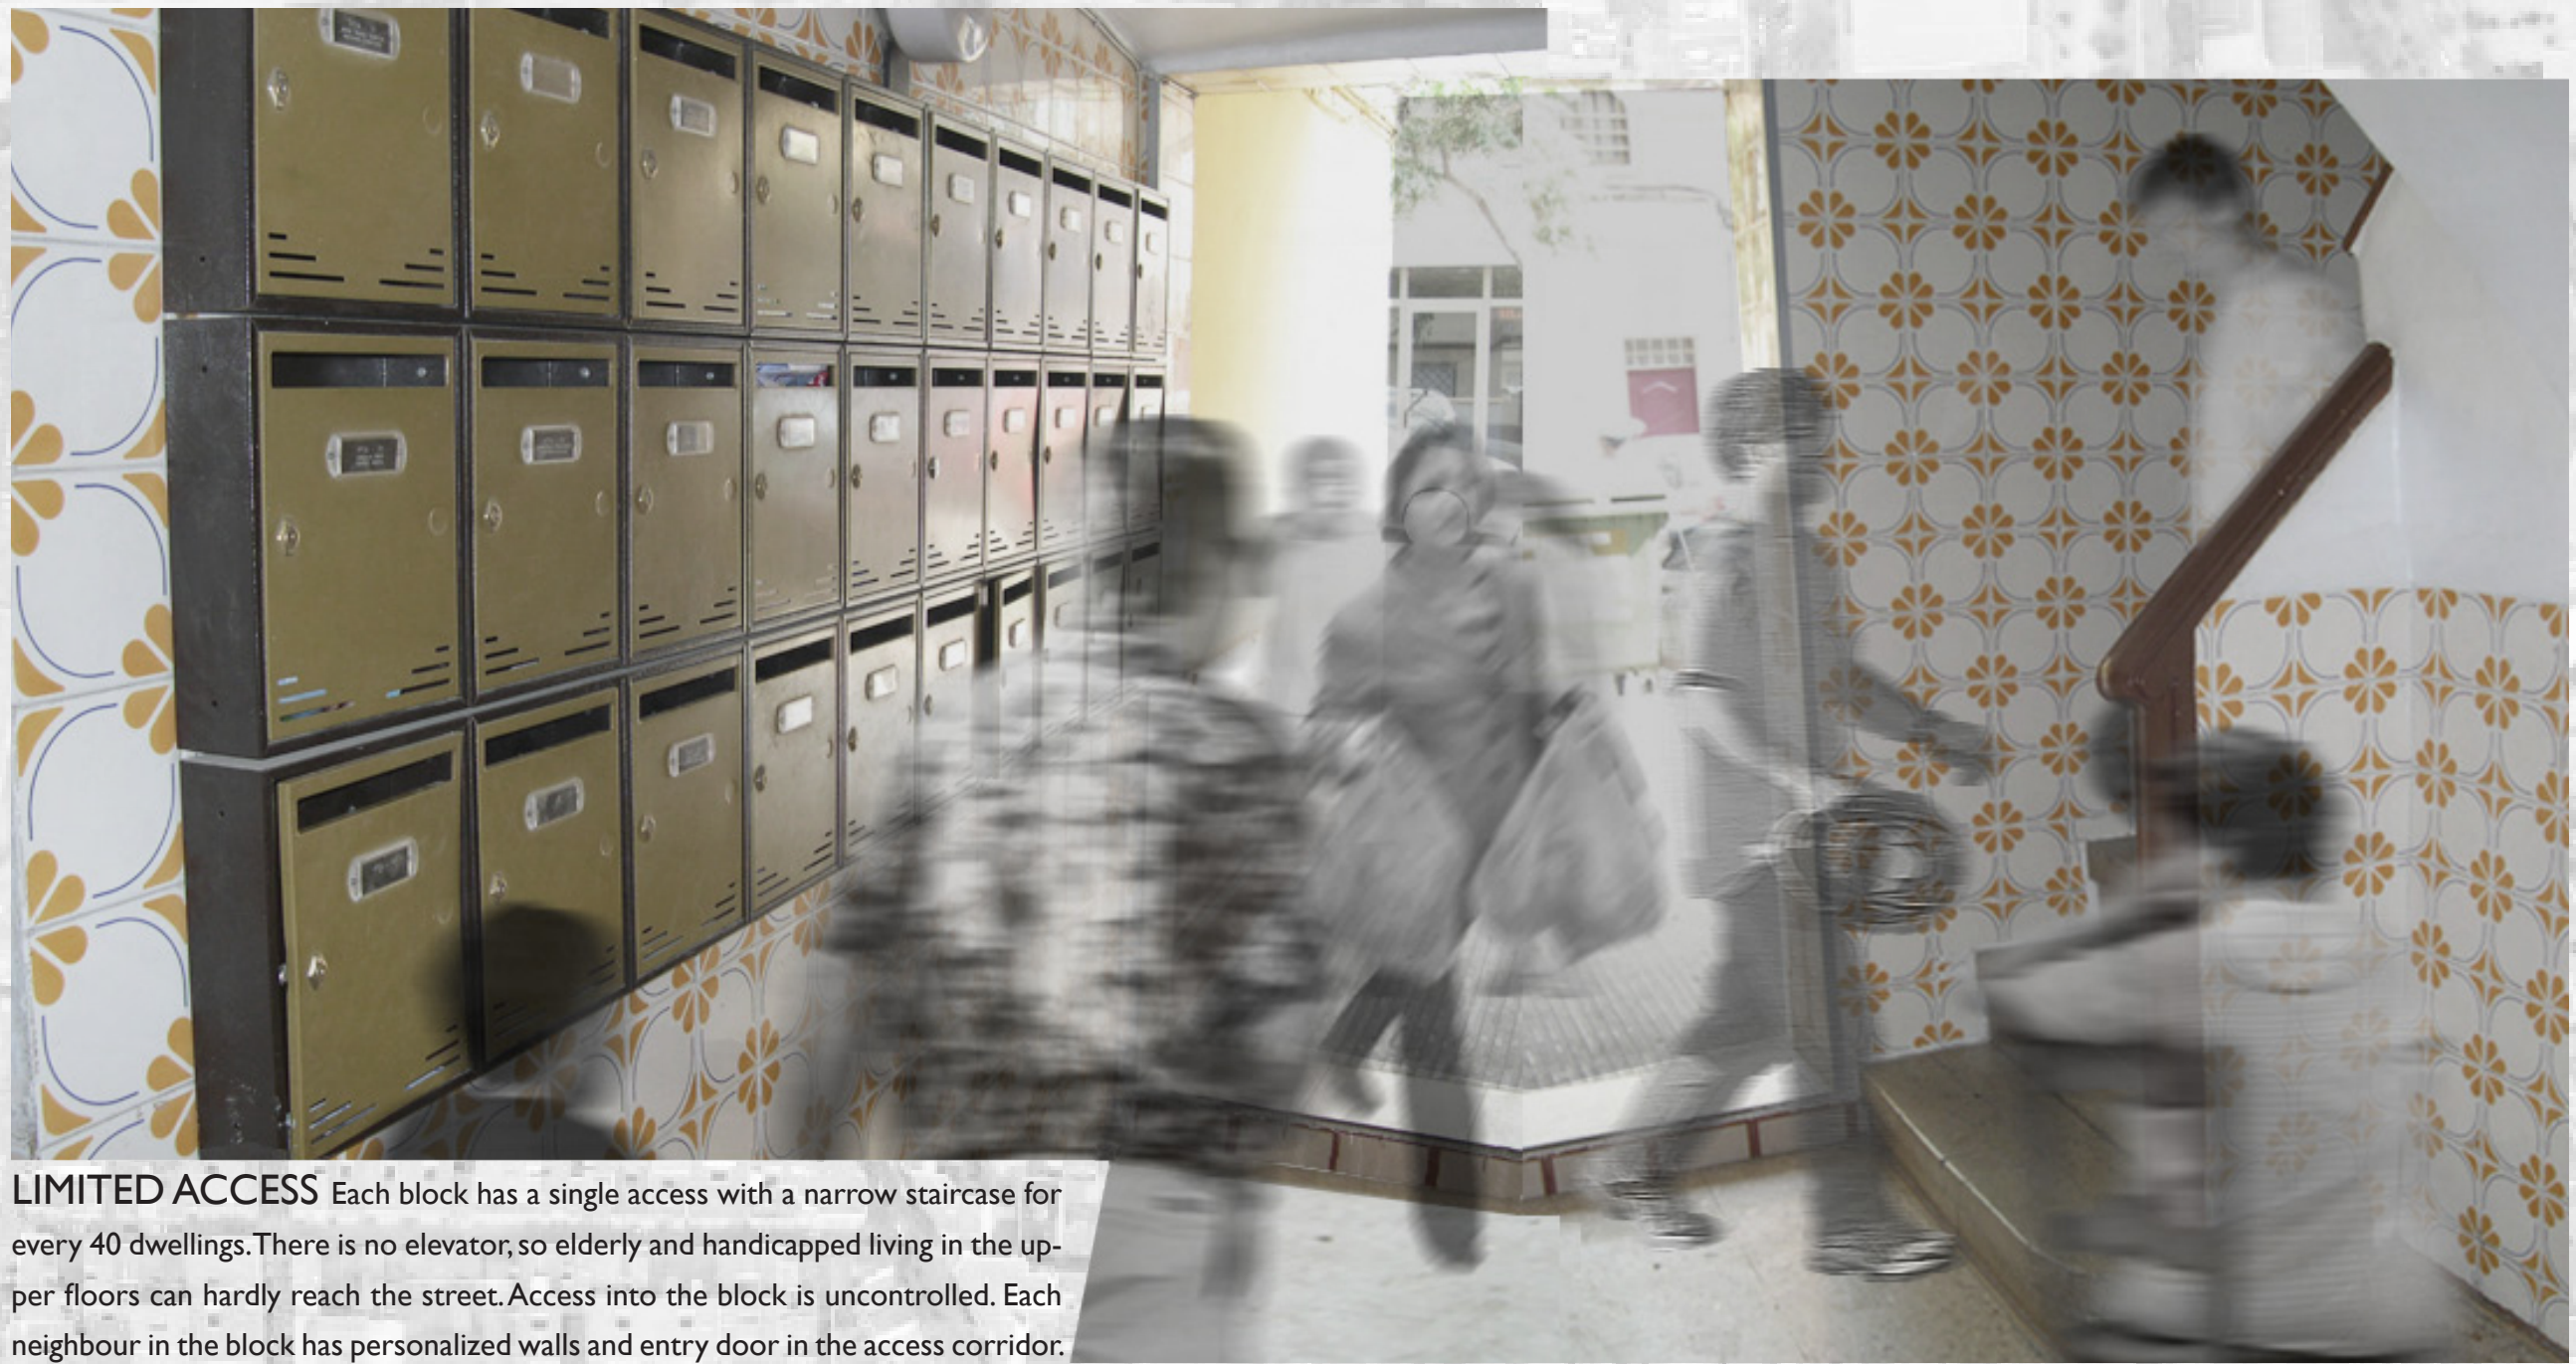
LIMITED ACCESS Each block has a single access with a narrow staircase for every 40 dwellings. There is no elevator, so elderly and handicapped living in the upper floors can hardly reach the street. Access into the block is uncontrolled. Each neighbour in the block has personalized walls and entry door in the access corridor.

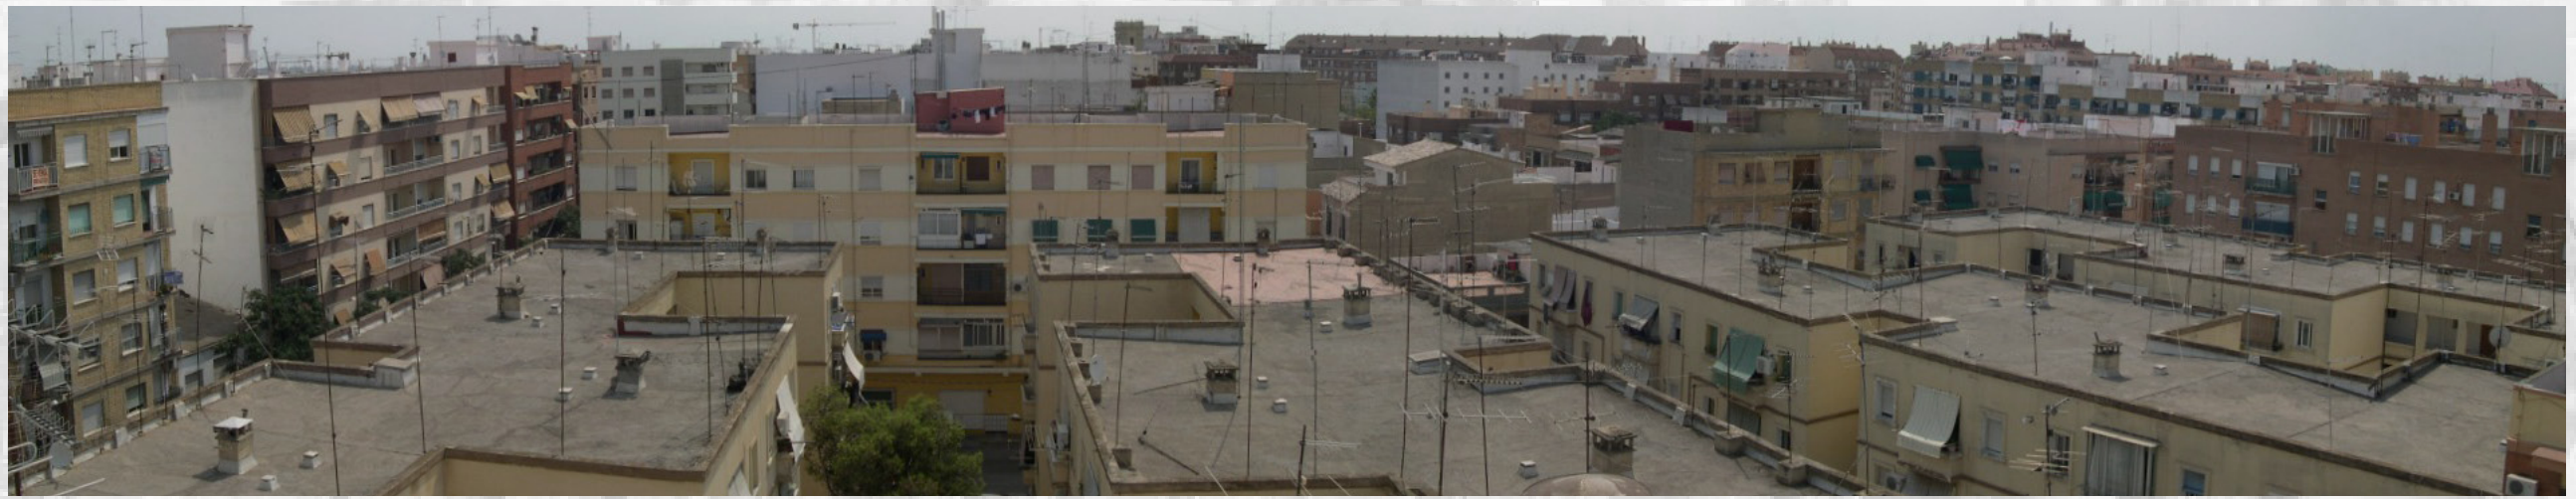
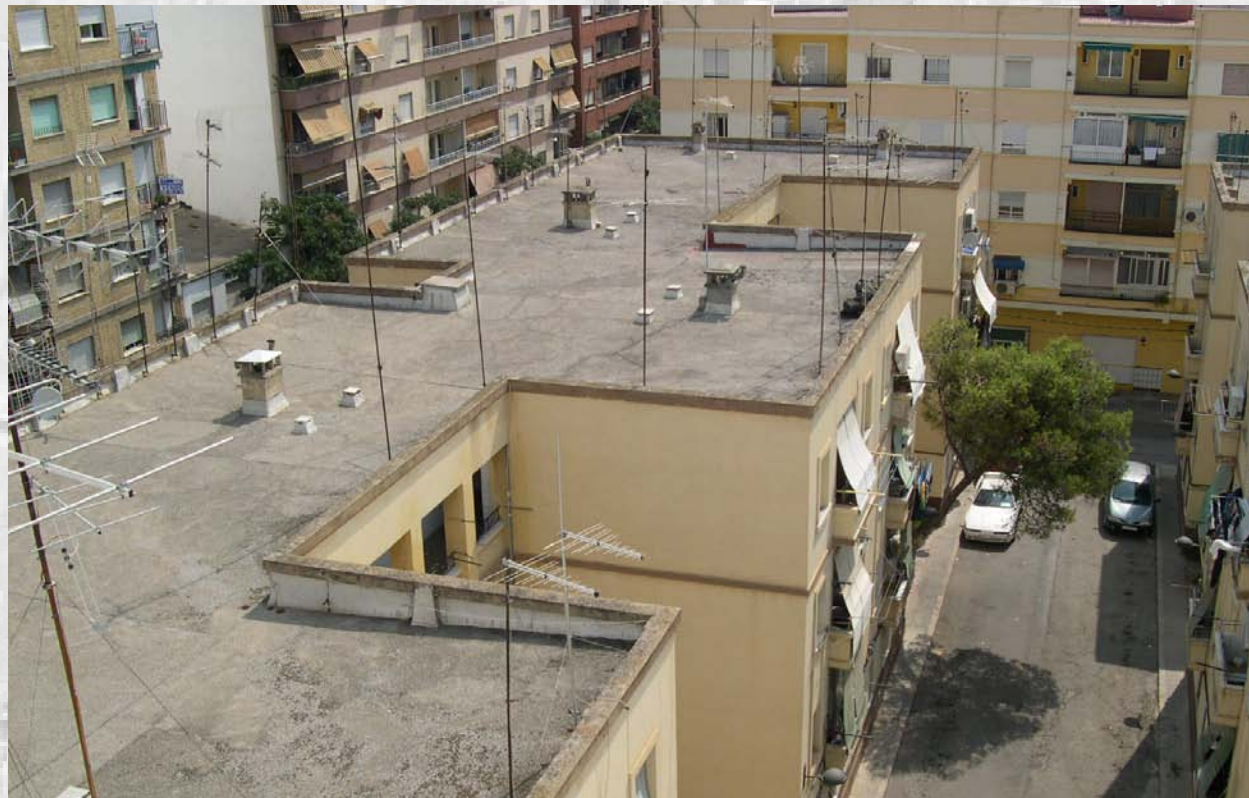
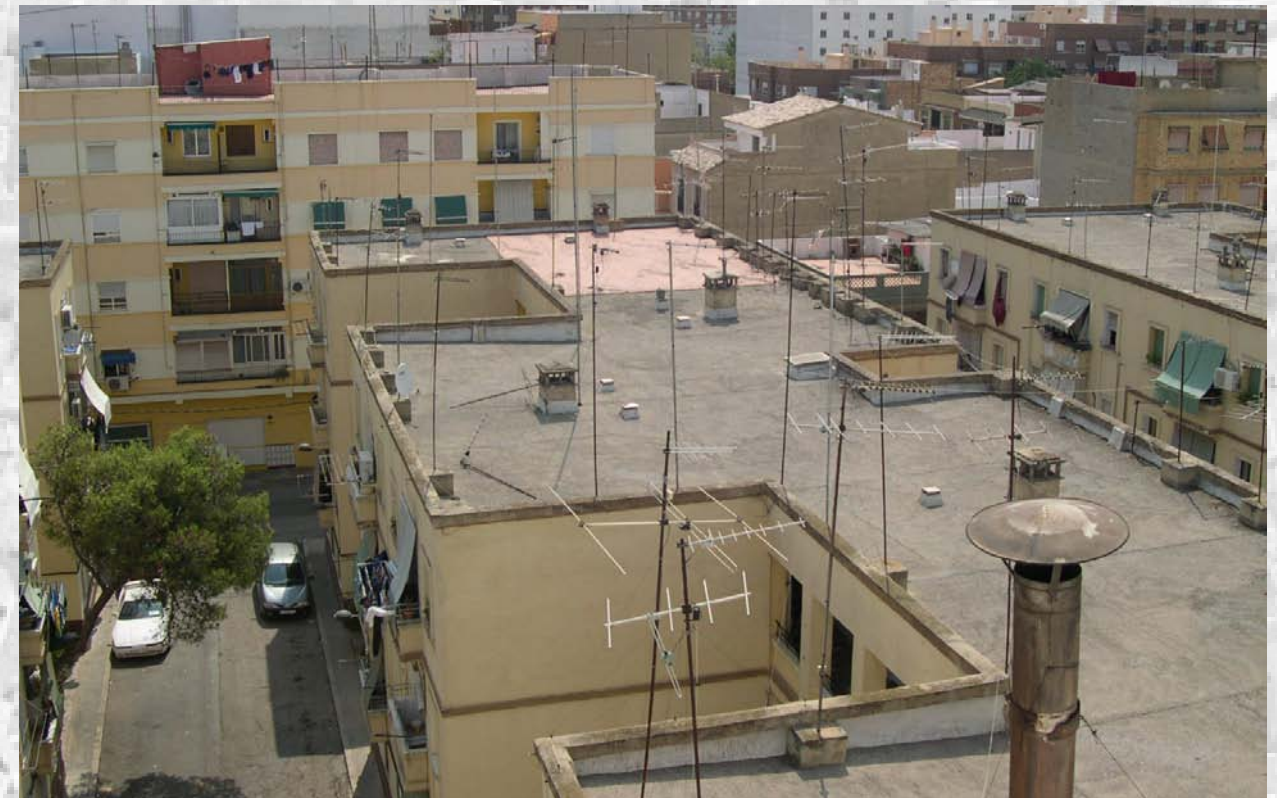
LACK OF INSULATION

There was waterproofing problems due to aging of materials and not enough slope. Ducts ventilation didn't work properly due to its insufficient height. Antennae were old and anywhere. Access to the roof was complicated. There was no specific service rooms. Water and electrical counters are placed in cupboards on the corridors. Wiring materials were obsolete and infradimensioned.

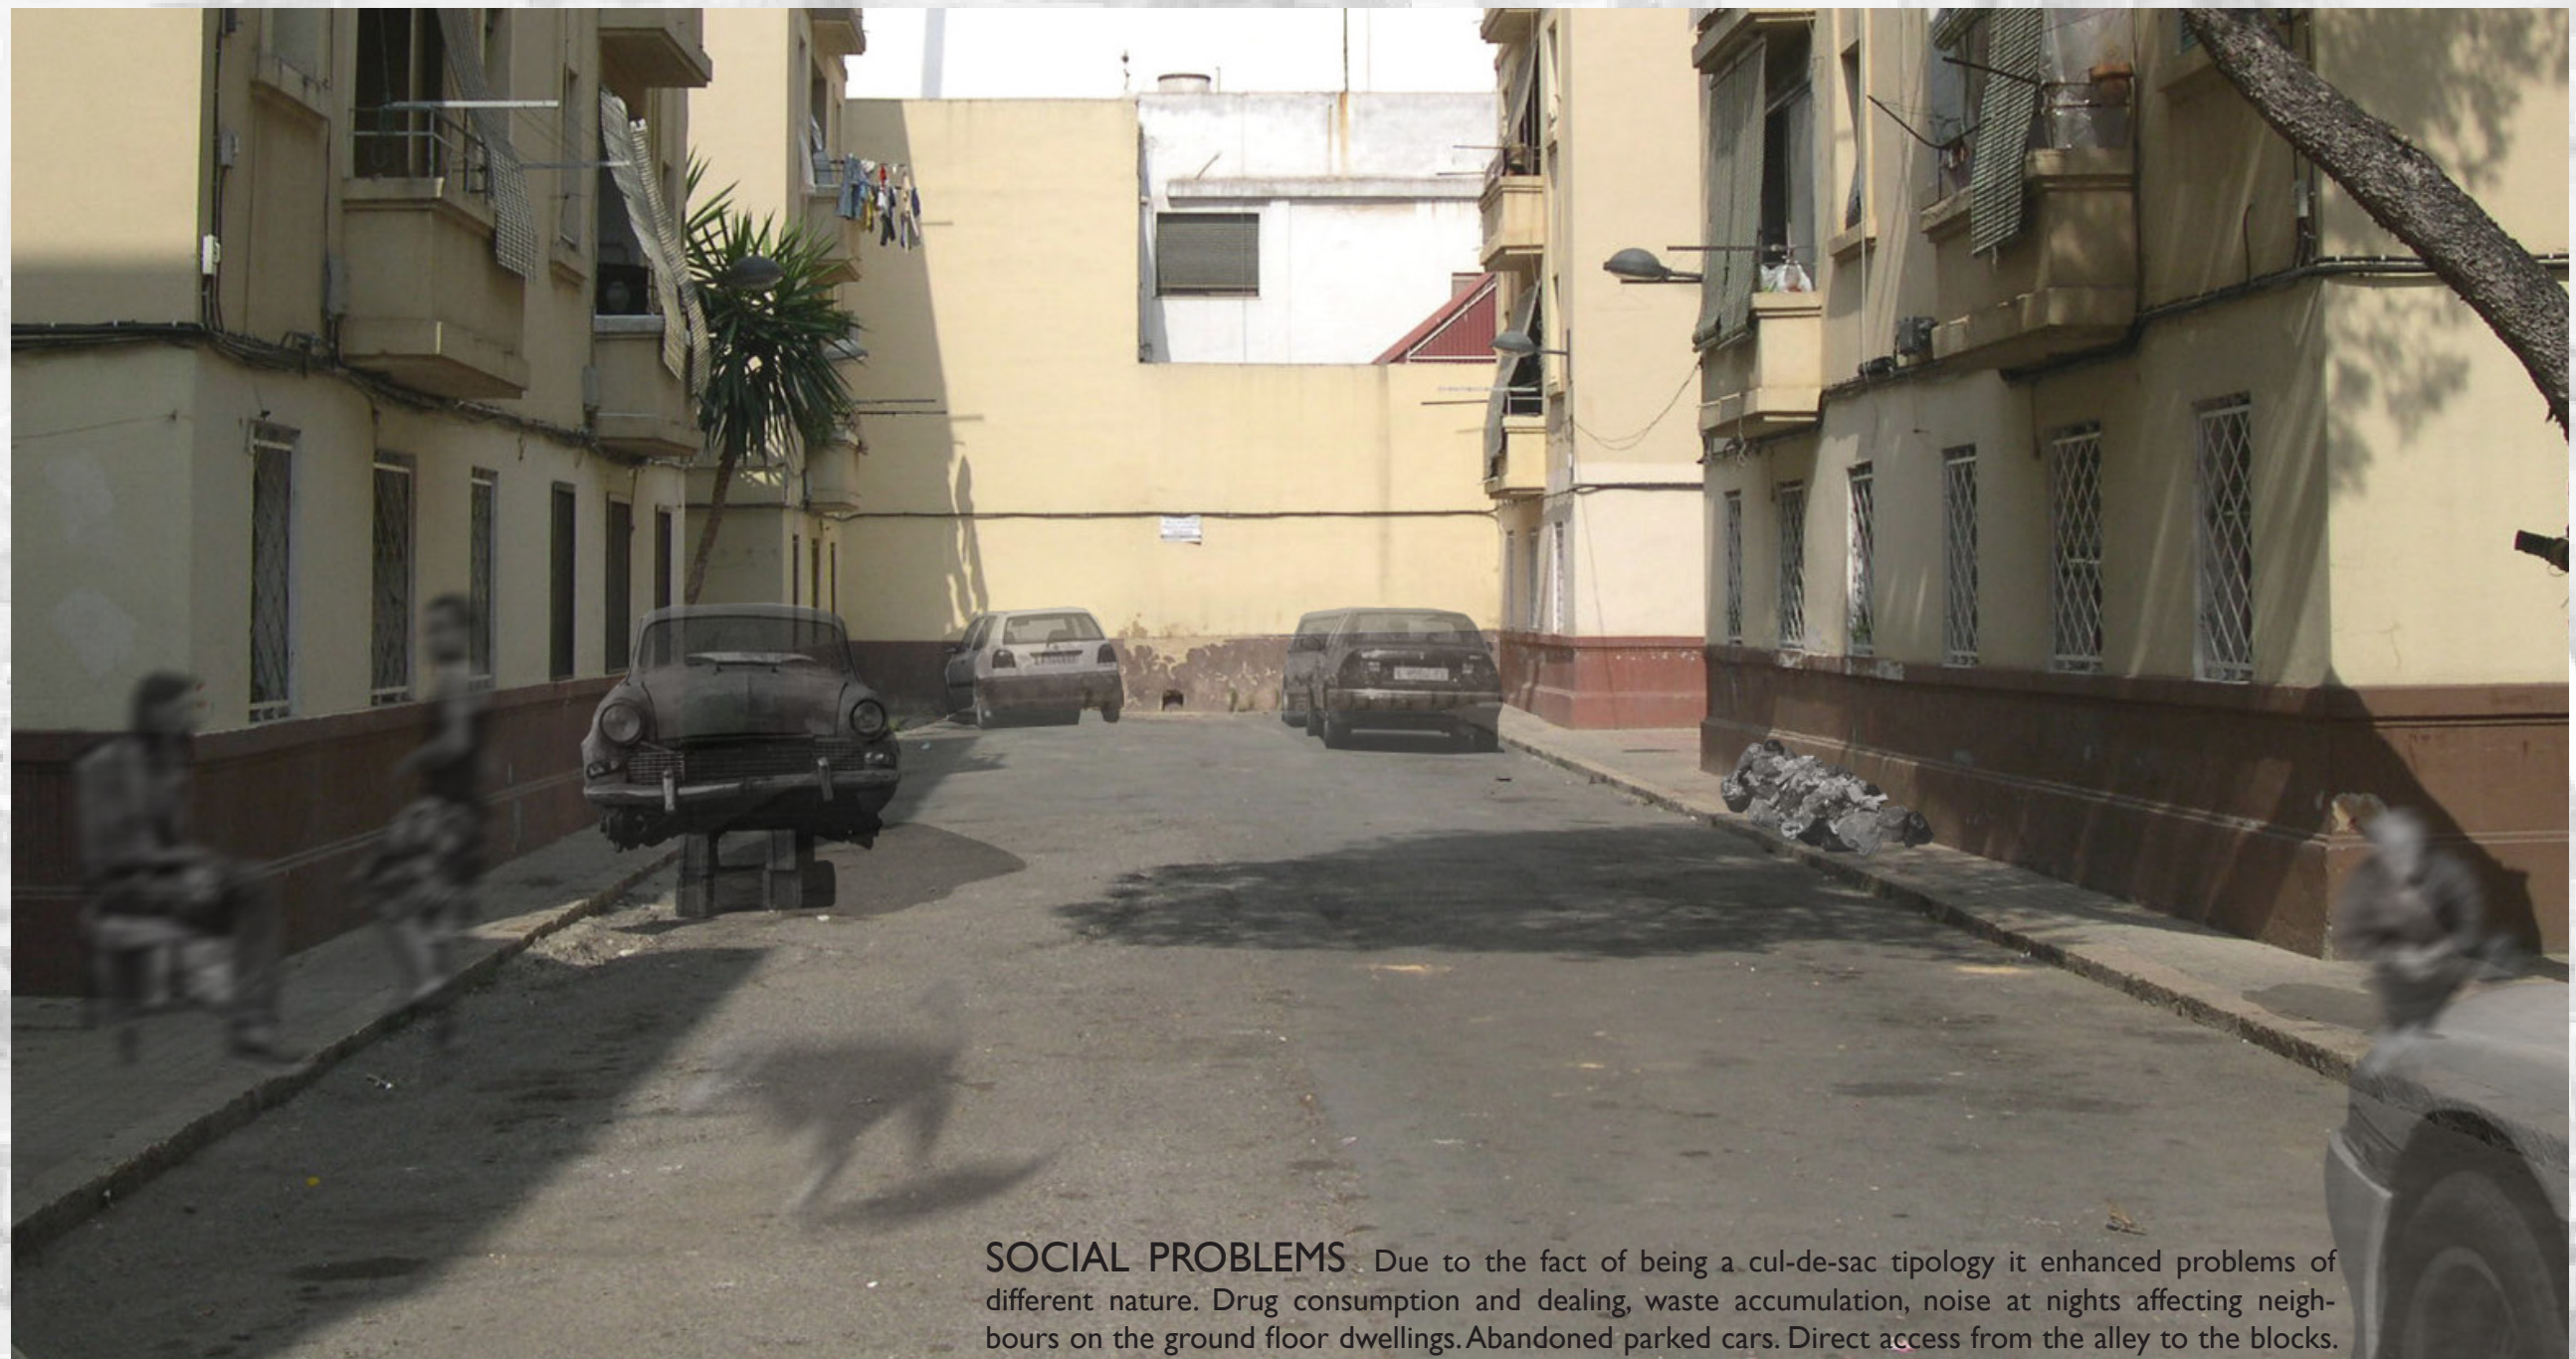
SOCIAL PROBLEMS Due to the fact of being a cul-de-sac typology it enhanced problems of different nature. Drug consumption and dealing, waste accumulation, noise at nights affecting neighbours on the ground floor dwellings. Abandoned parked cars. Direct access from the alley to the blocks.
